THE UNITED STATES  
STRATEGIC BOMBING SURVEY

THE ELECTRIC POWER  
INDUSTRY  
OF  
JAPAN

(Plant Reports)

Electric Power Division

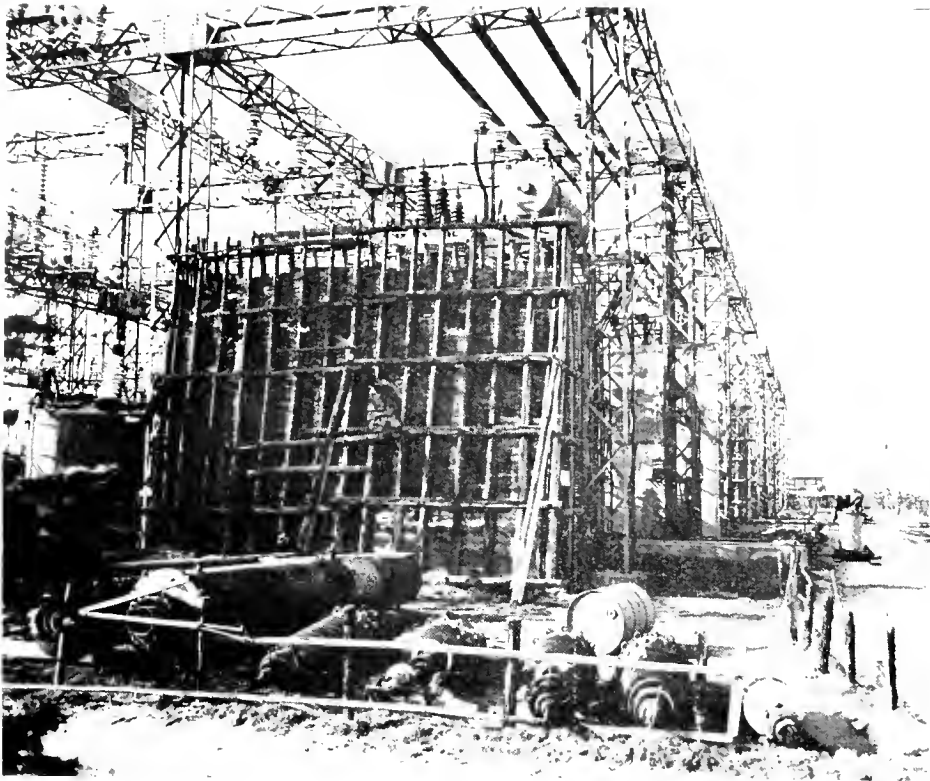
Photo 3—Damaged lightning arrestors and blast wall

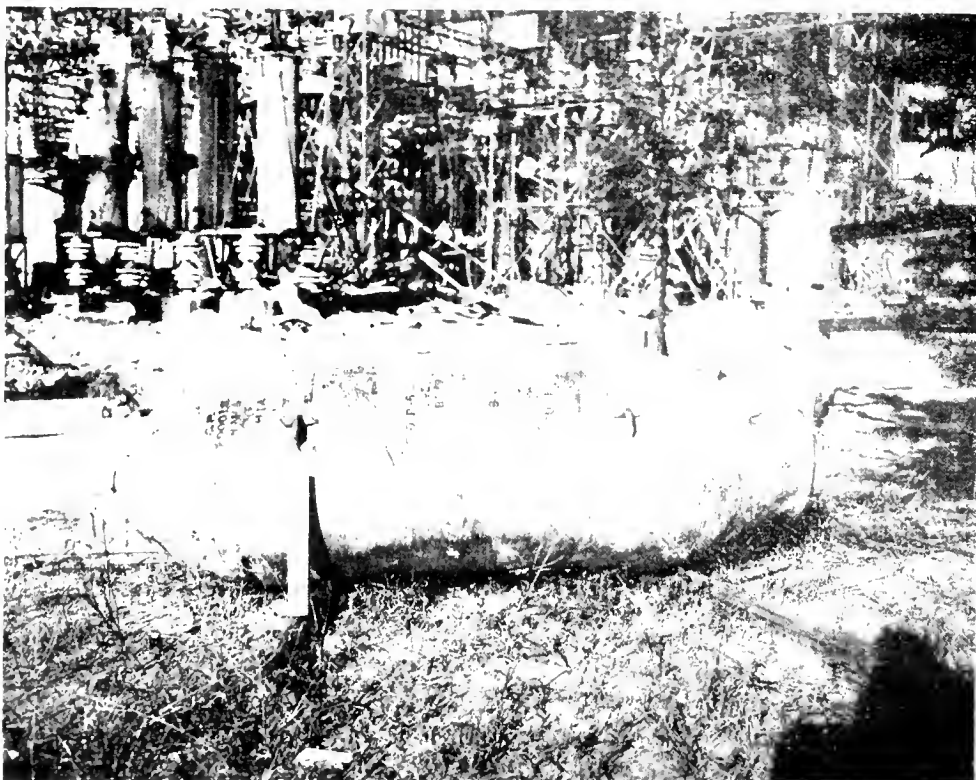
Photo 4—2,000 lb. unexploded bomb (12-inch stick on left)

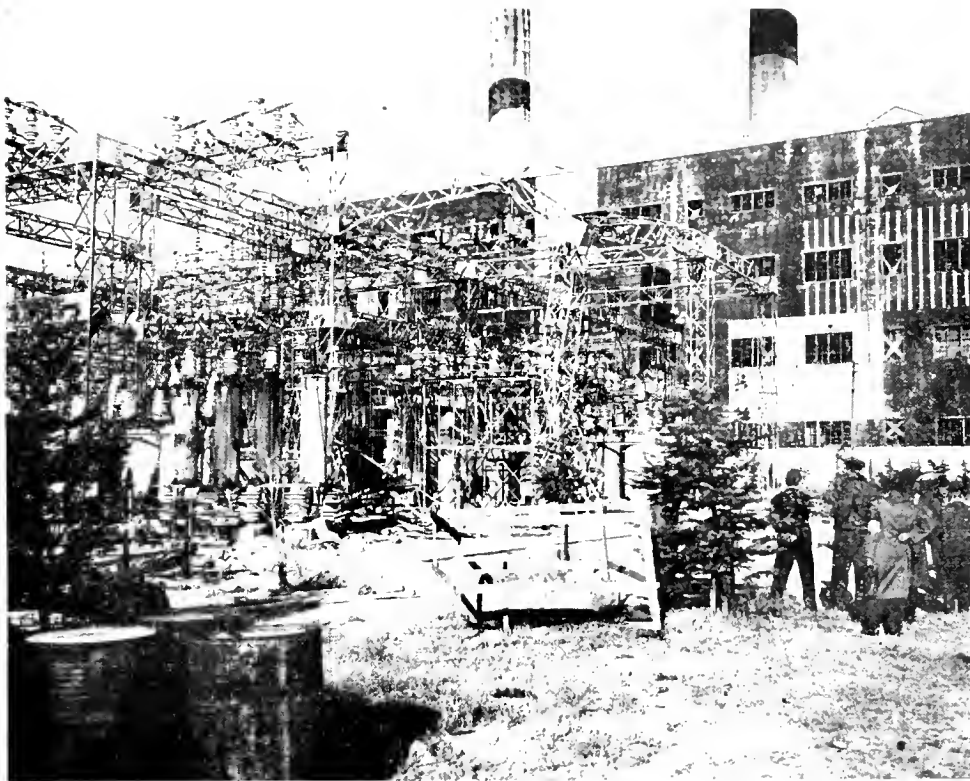
Photo 5—Damage to arrestors and substation

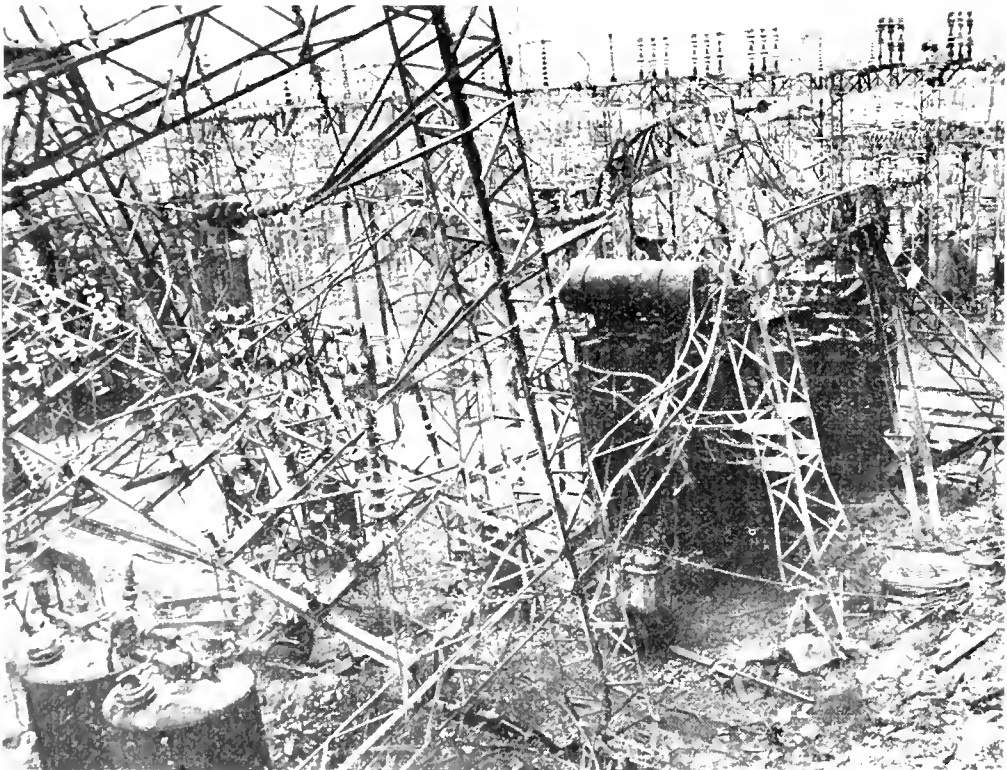
Photo 8—View of damaged switch and transformer yard

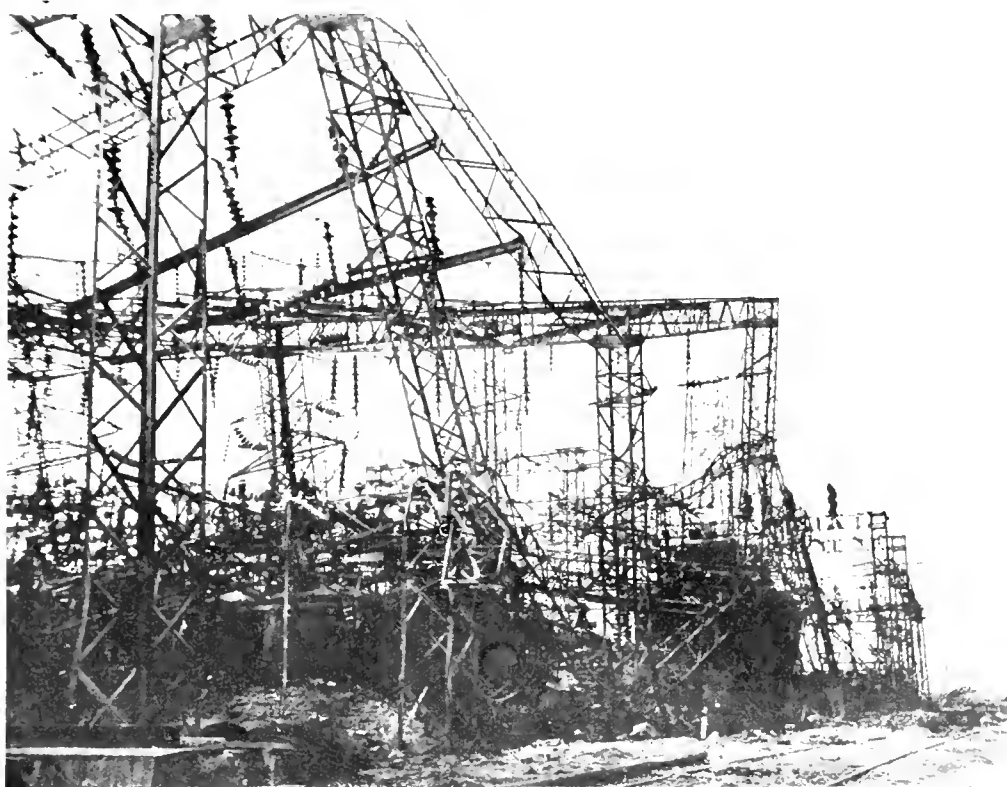
Photo 9—Ground view of damaged switch and transformer yard

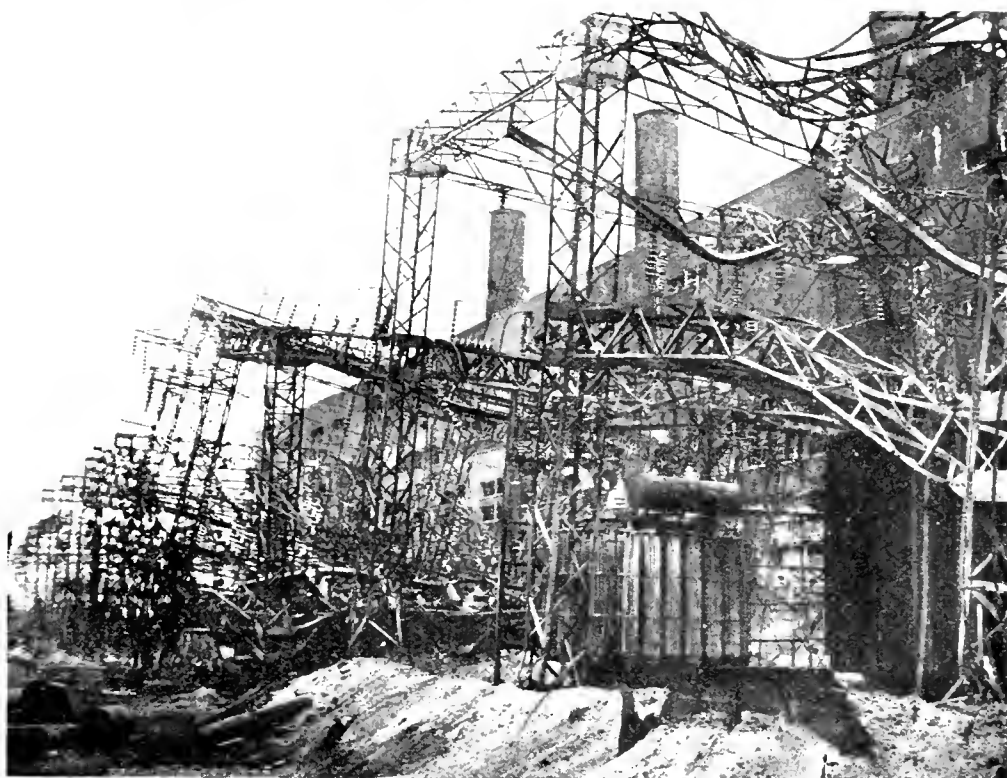
Photo 10—Ground view of damaged switch and transformer yard

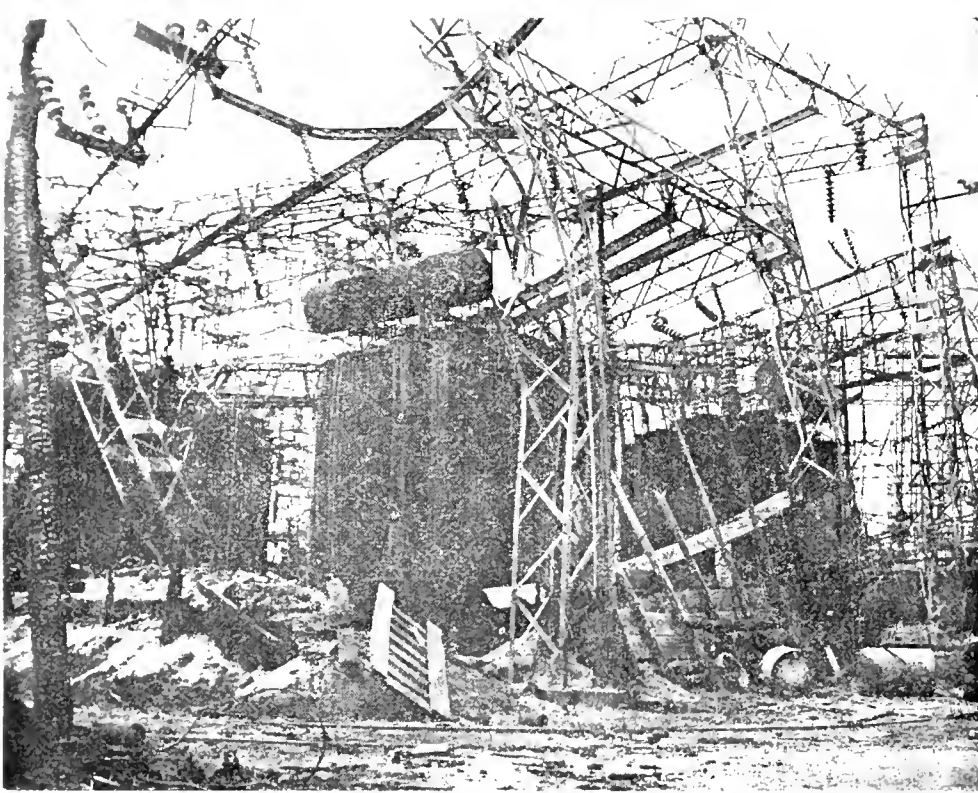
Photo 11—Closer view of damaged switch and transformer yard

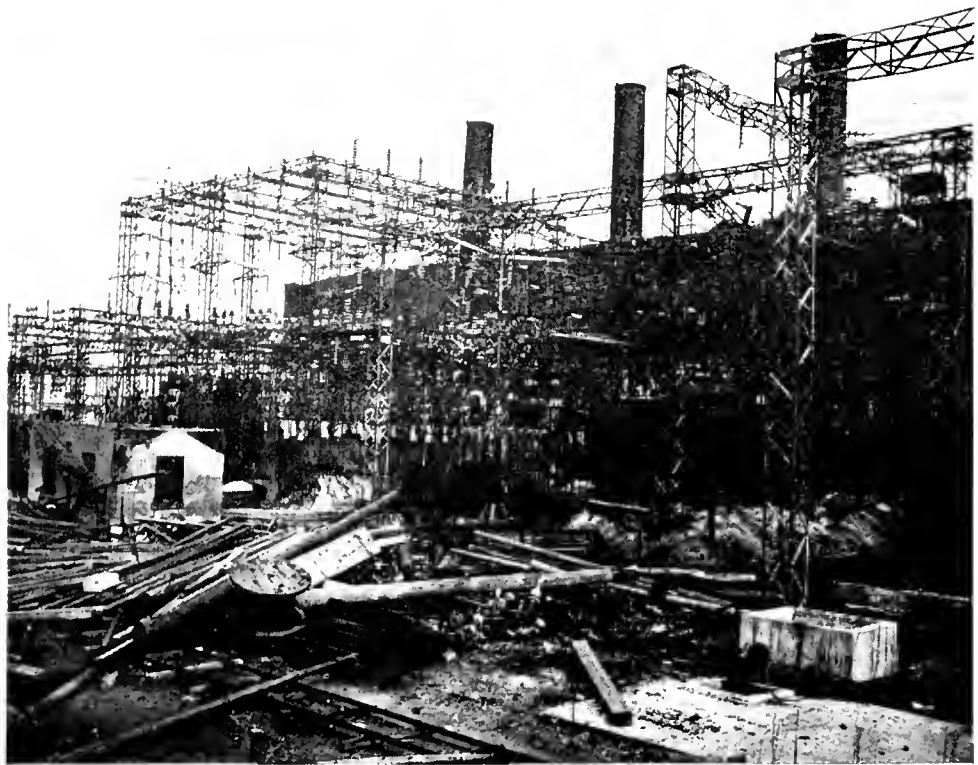
Photo 12—General view of part of switch and transformer yard showing some of damaged section

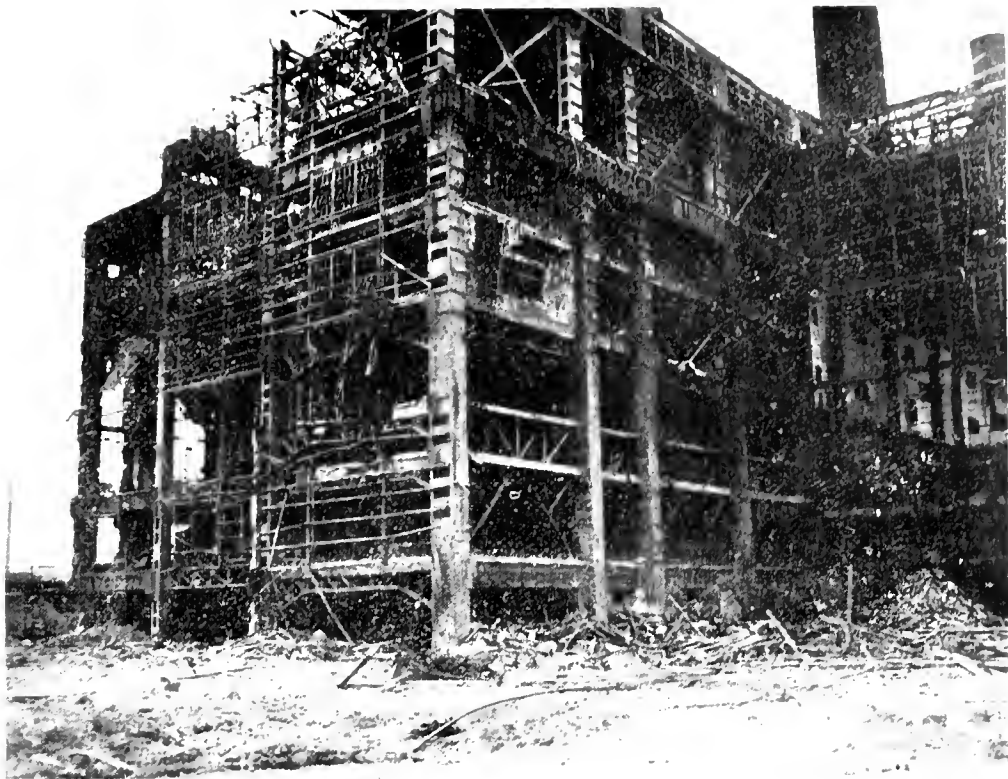
Photo 3—View of damaged south end of boiler house

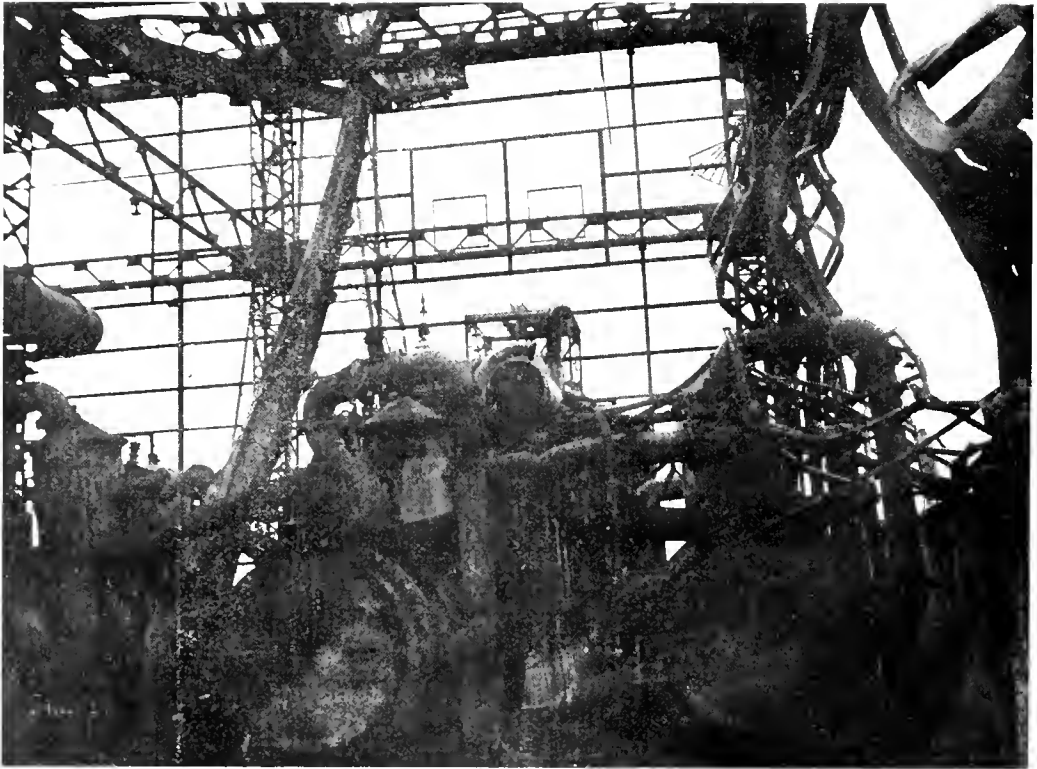
Photo 13—View of damaged oil coolers for main transformers, station transformer directly behind

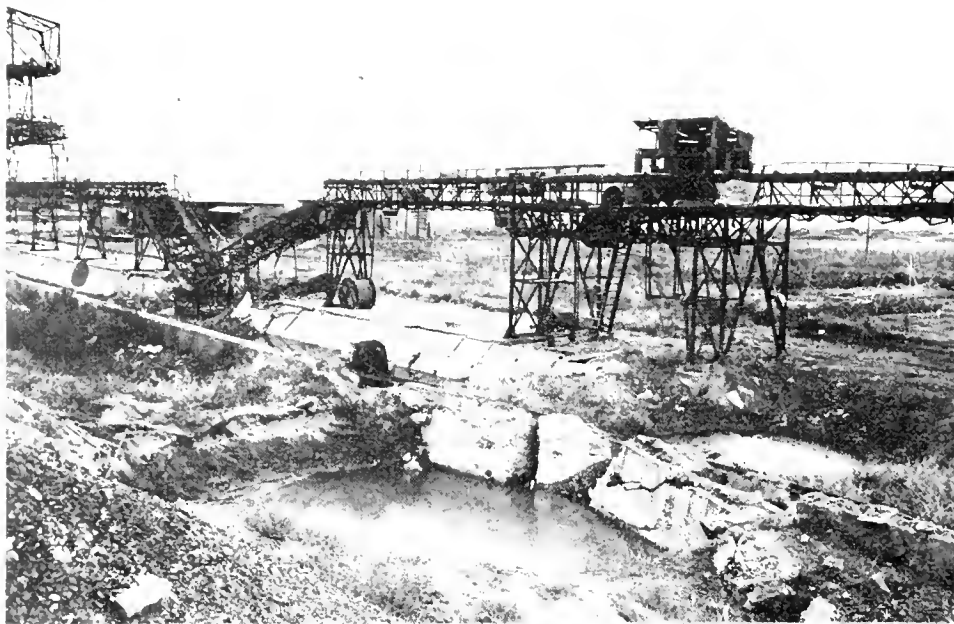
Photo 3—Damaged coal conveyors and crane

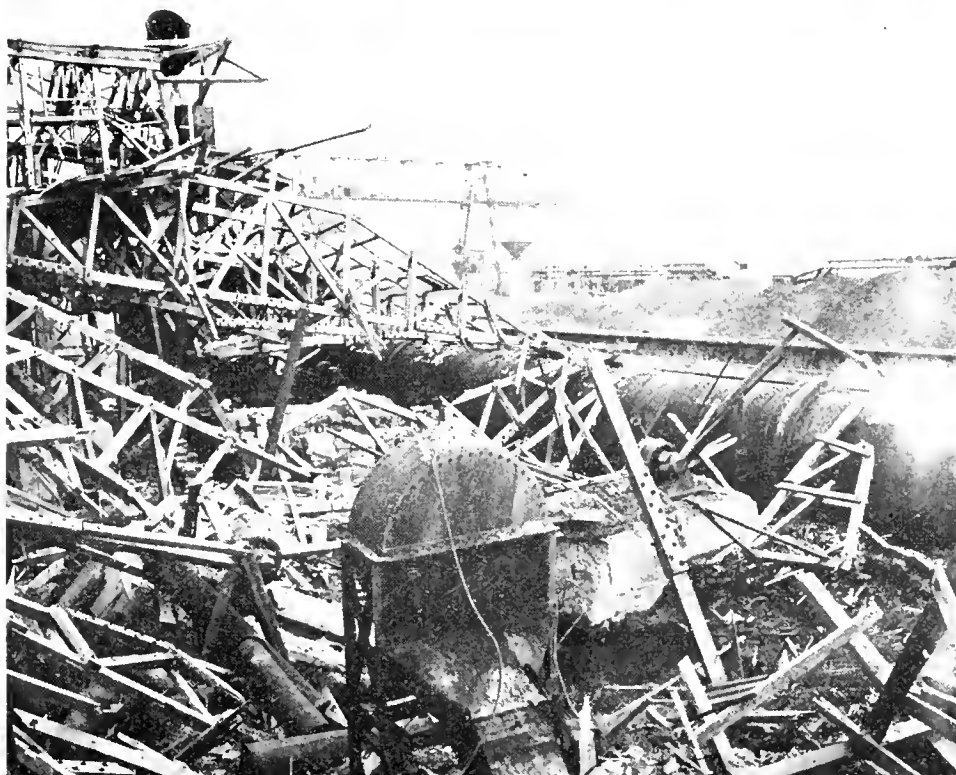
Photo 6—Damaged coal driers blown completely off foundation —Raid number 2

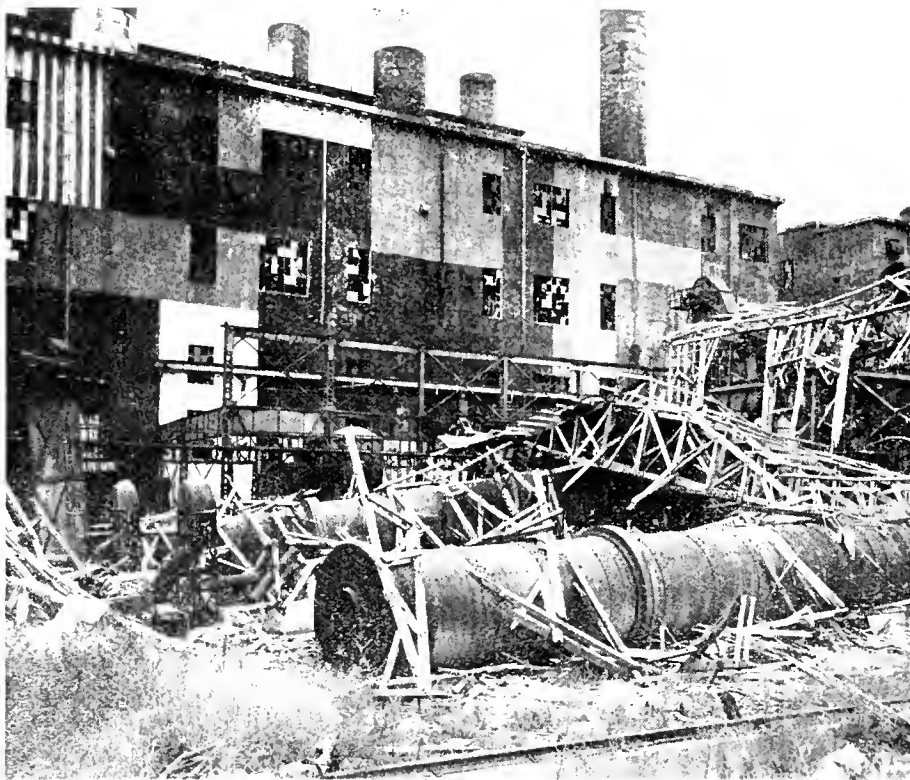
Photo 7—Damaged coal driers and general debris. Note camouflage paint on building. Raid number 2

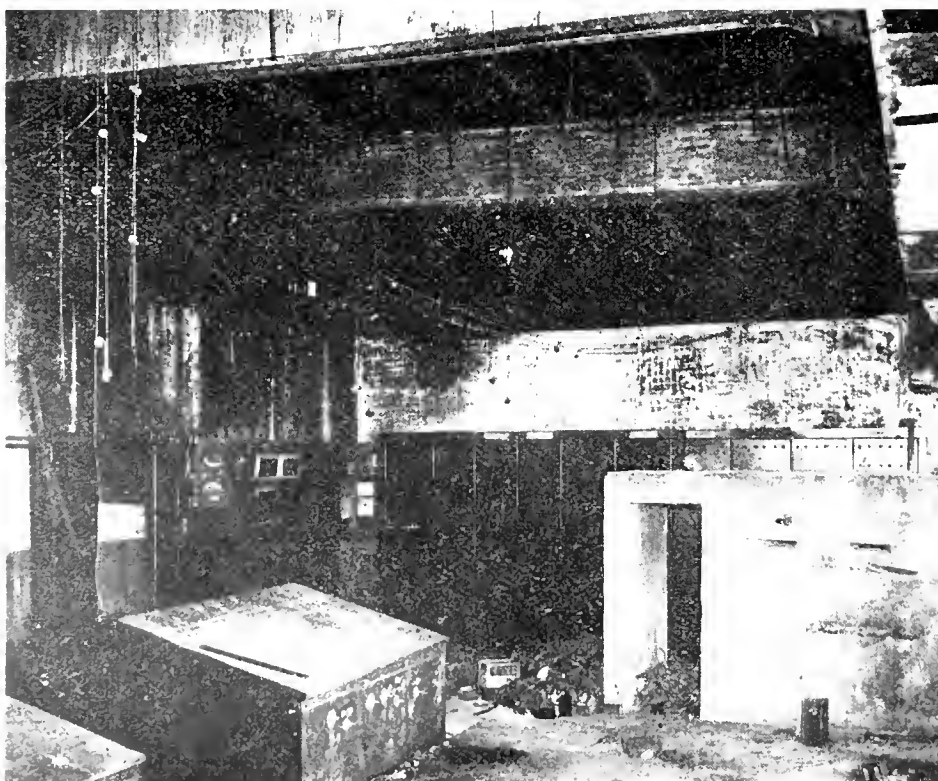
Photo 8—Burned out control room. Note bomb shelter for operators. Raid number 2

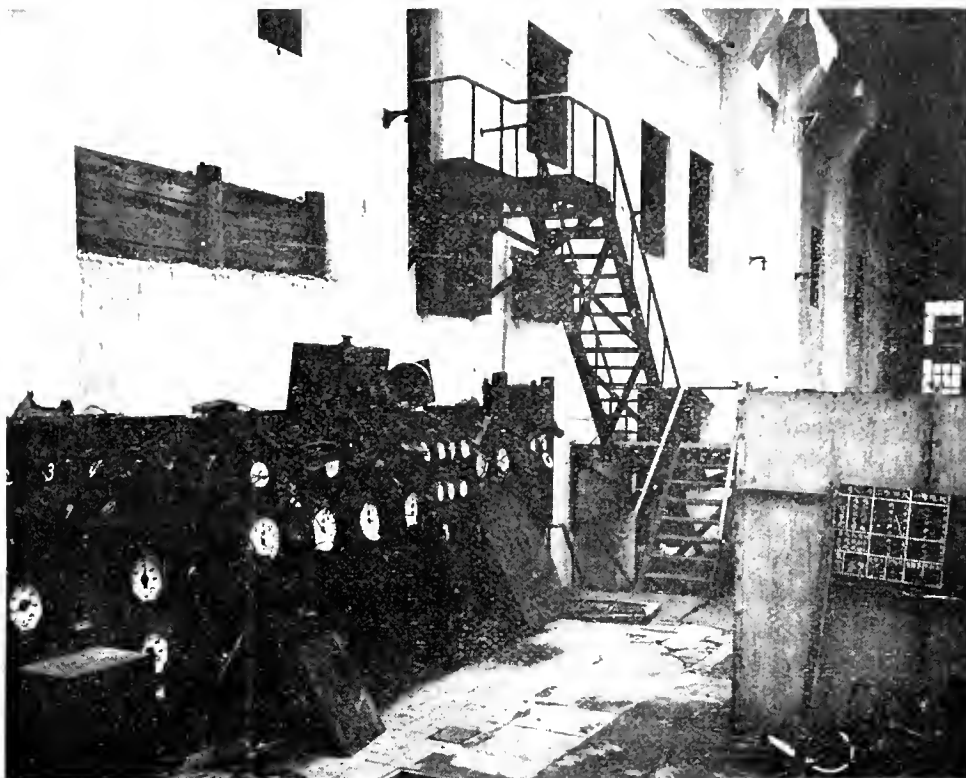
Photo 9—Damaged turbine control instrument board in generator hall—Note blast protective barrier wall—Raid number 2

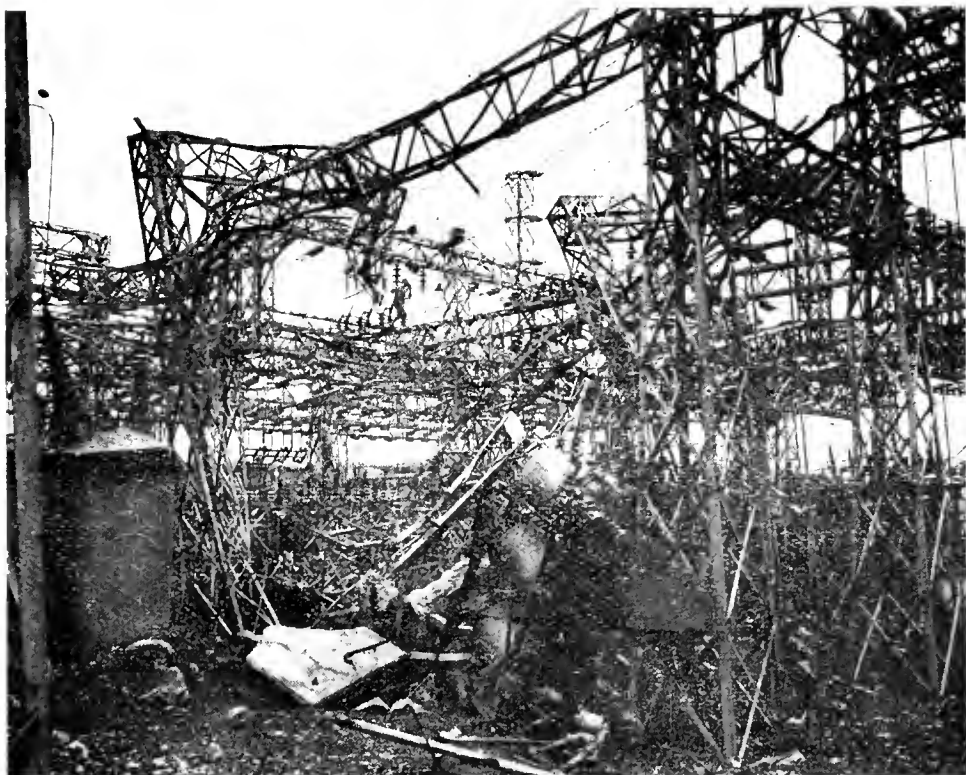
Photo 10—Destroyed O.C.B. and other damage to switch yard—Raid number 2

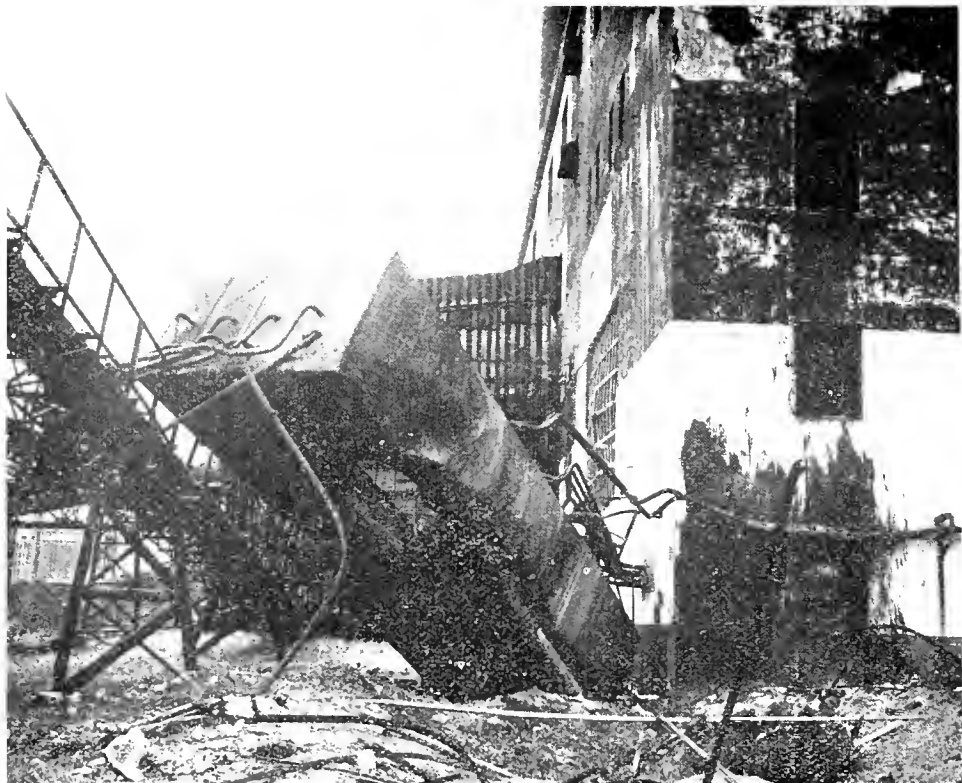
Photo 11—Damaged blow down tank - Raid number 3

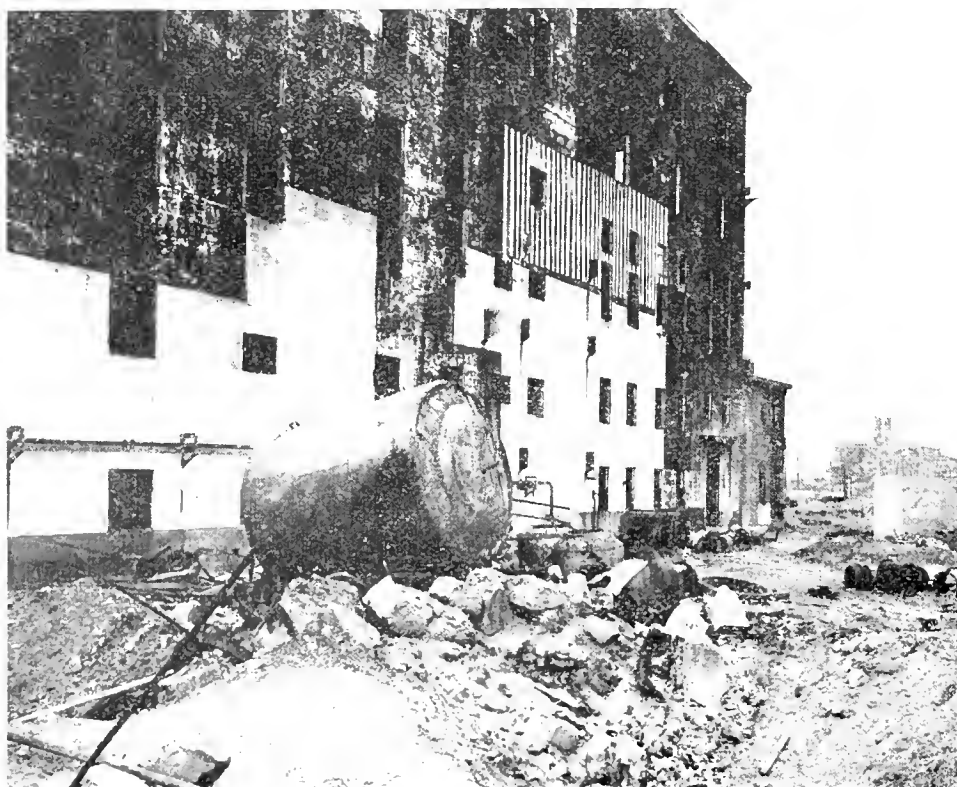
Photo 12—Damaged oil container blown completely out of ground—Raid number 3

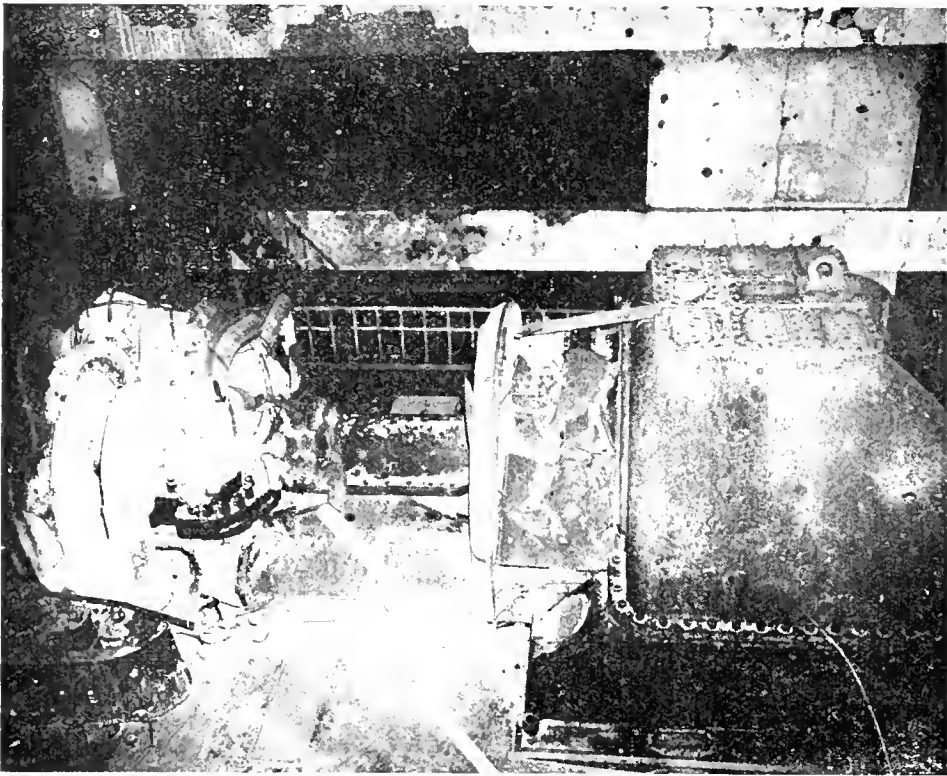
Photo 3—Damaged number 2 steam turbine

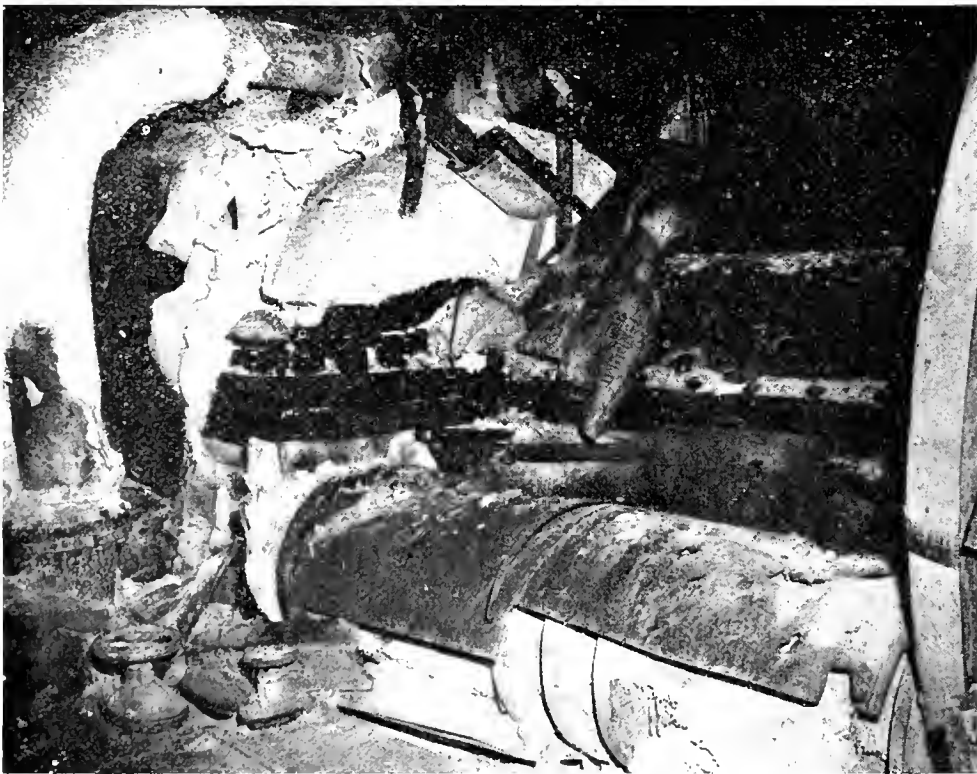
Photo 4—Close view of damaged number 2 steam turbine

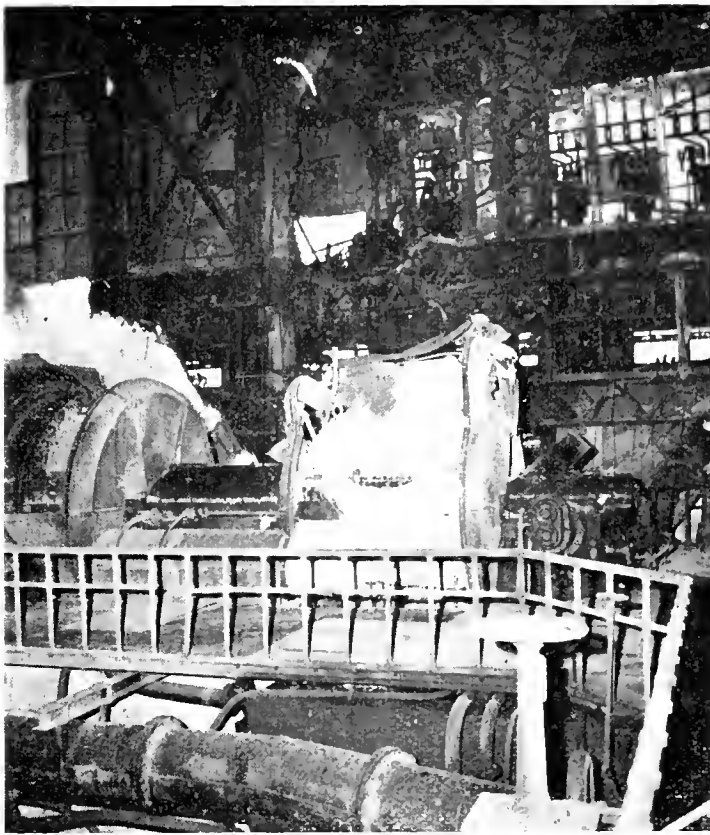
Photo 5—General view of blast effect in switch room and of number 2 steam turbine

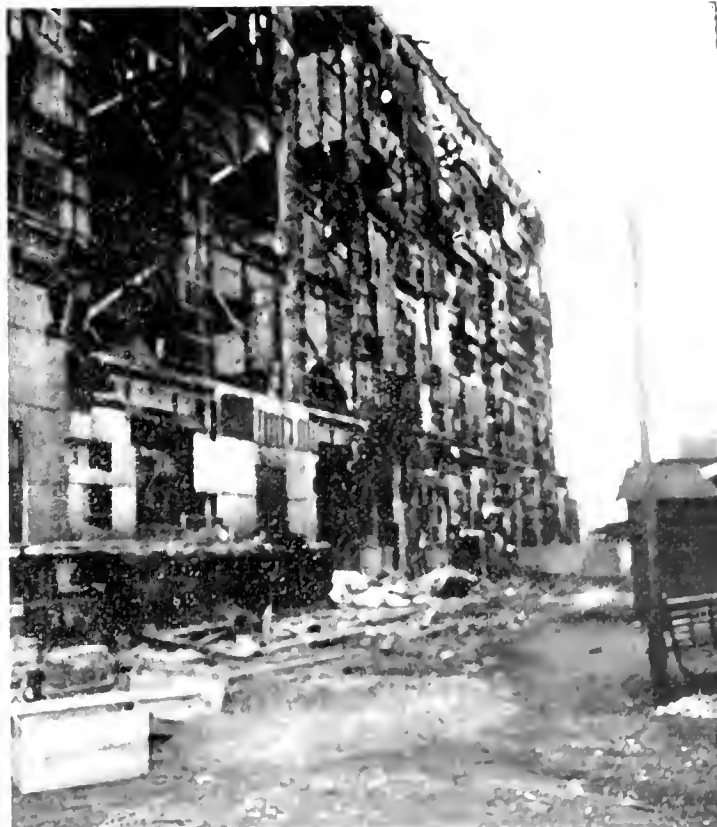
Photo 10—Damaged exterior of building

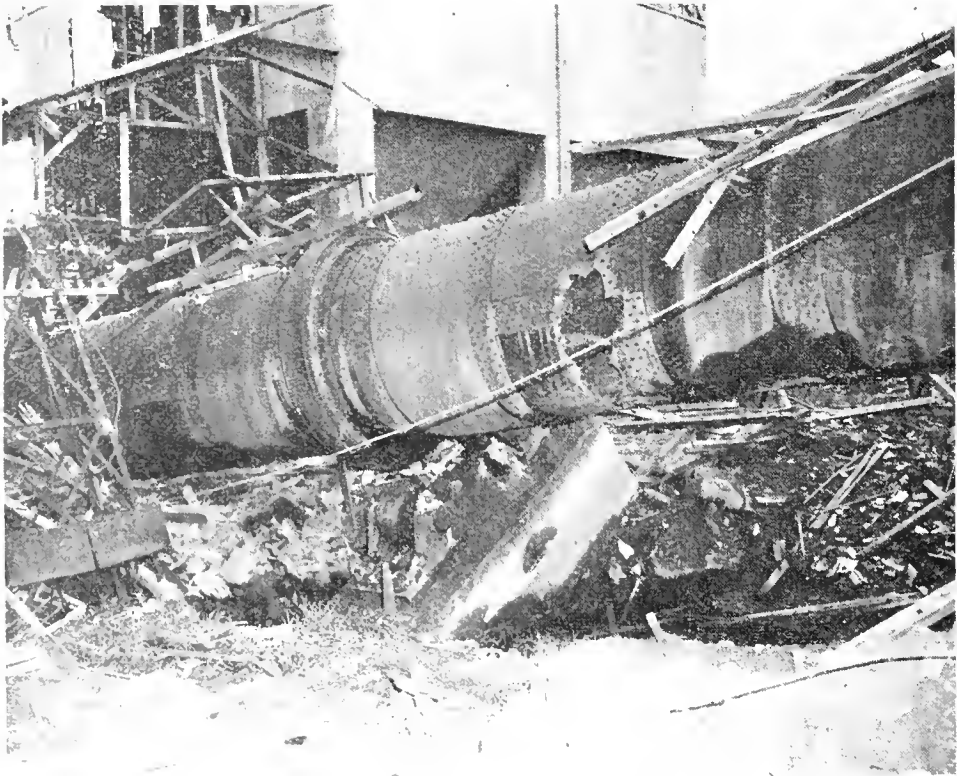
Photo 11—Damaged coal dryer and demolished  
water cooling inlet tunnel

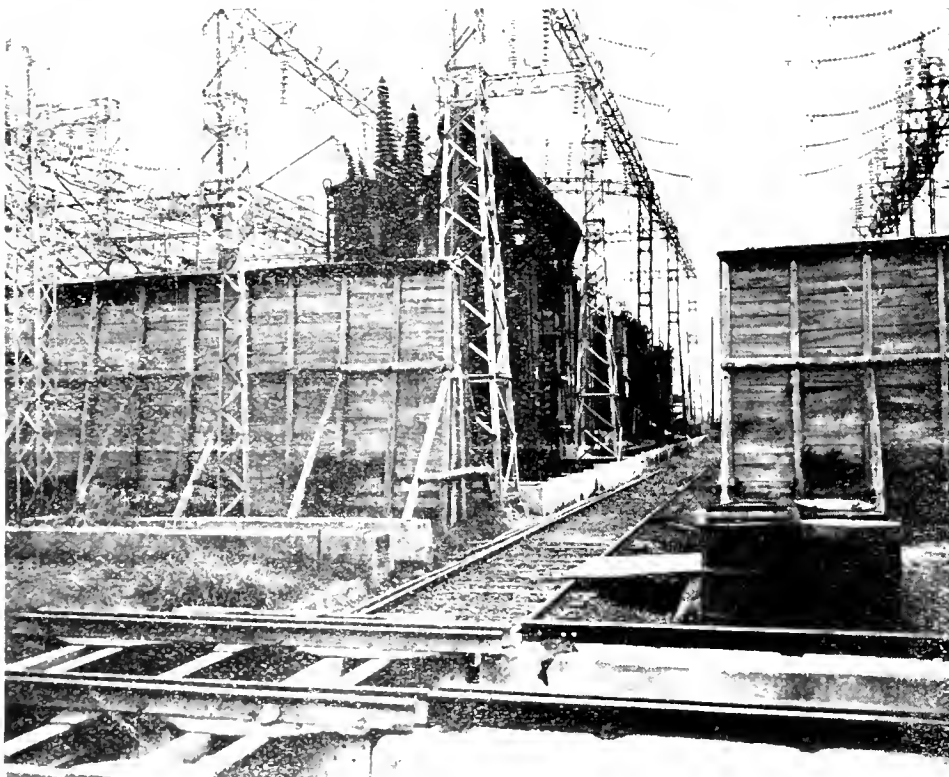
Photo 10—Iwakura Transformer banks, damaged transformers on far end

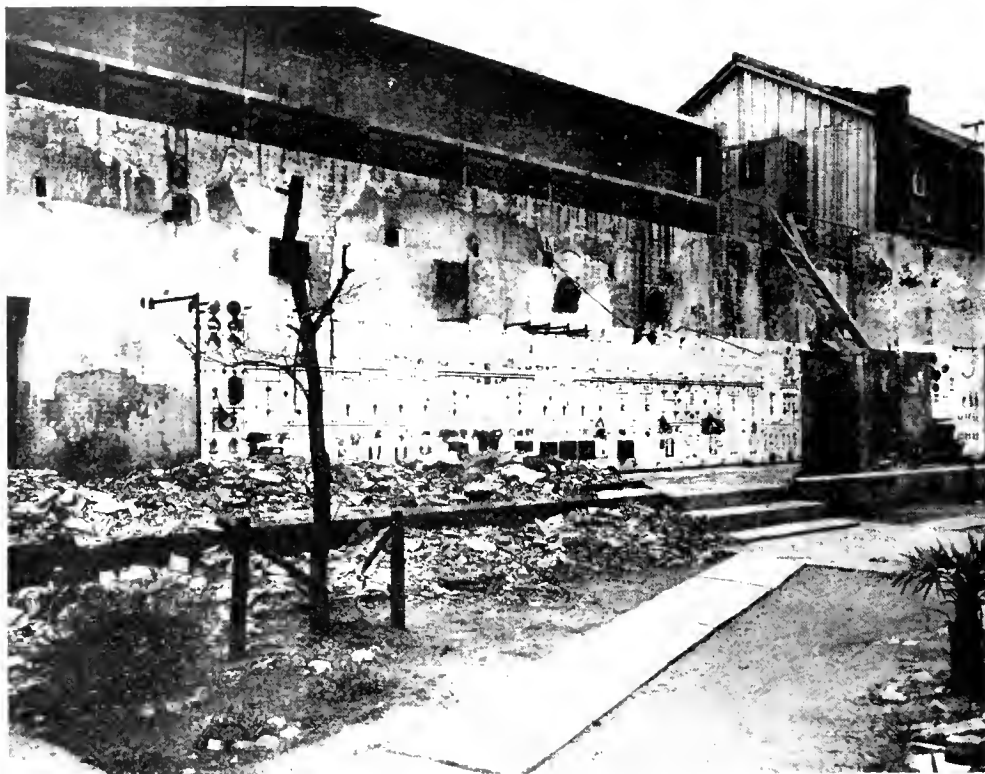
Photo 17—Rokugo—Remains of control board

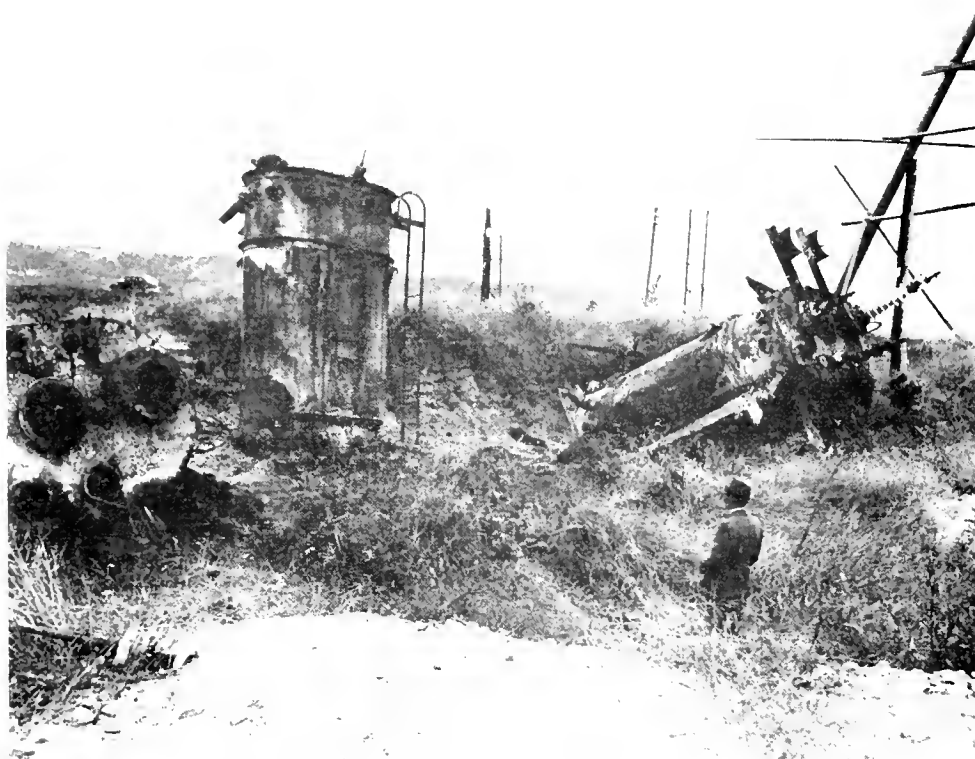
Photo 21—Taiko—Transformer bank of 3 -10000-KVA transformers completely destroyed by direct hit and fire

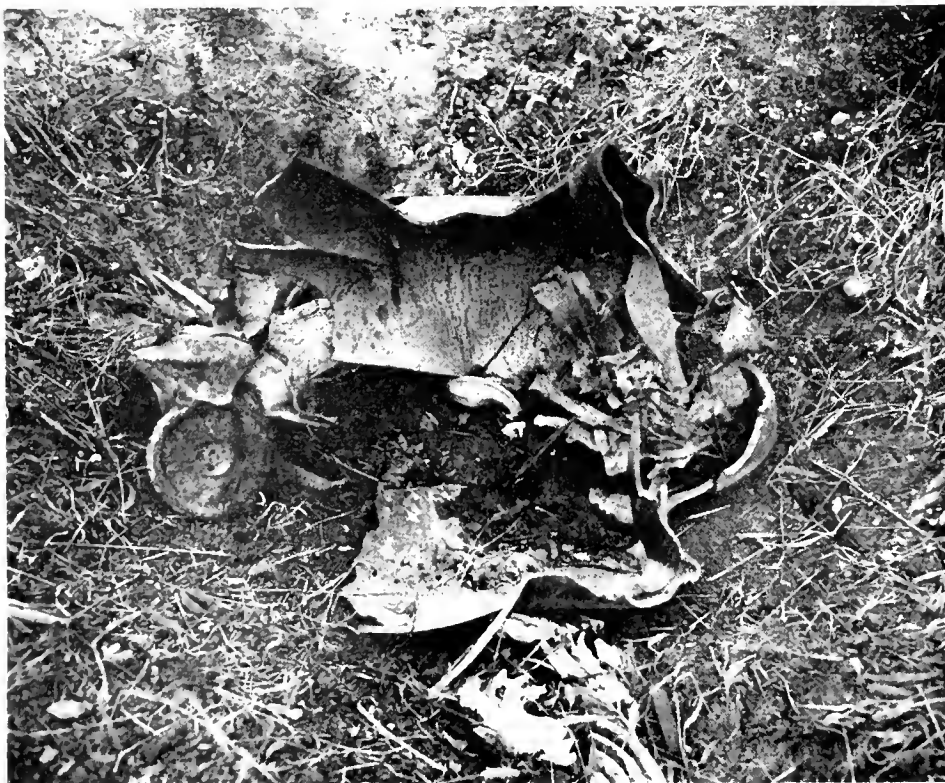
Photo 26—Taiko—Casing of 500 lb bomb found in bottom of crater at station

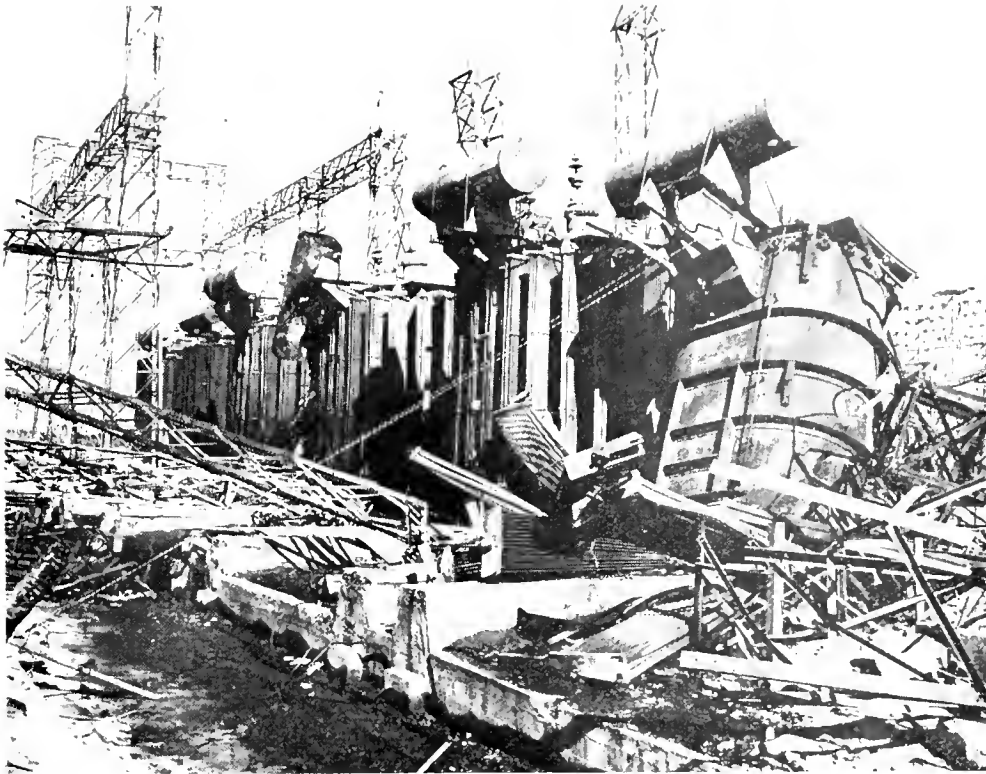
Photo 3—Bank of 6 damaged transformers

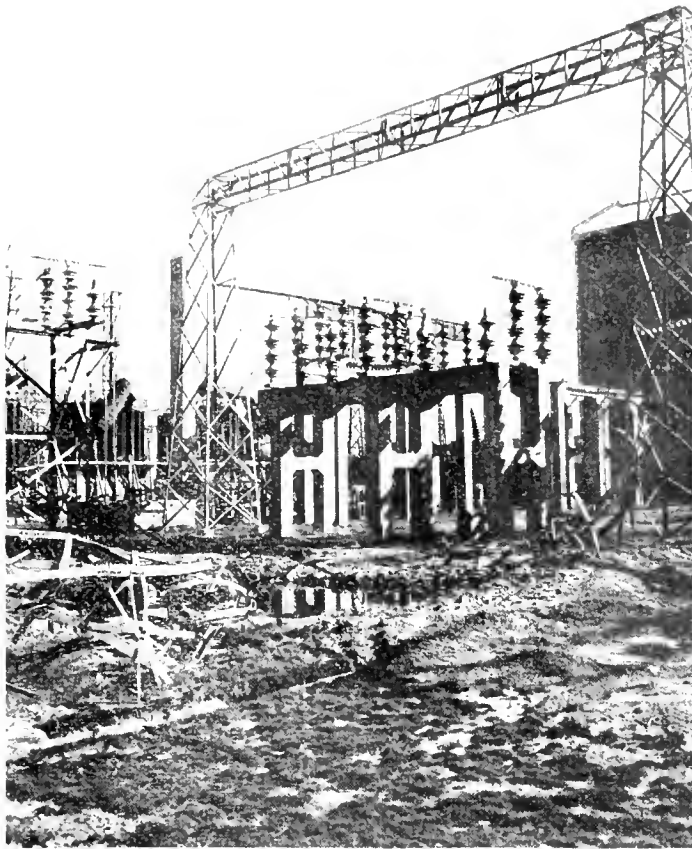
Photo 7—Direct hit on 154 KV bus structure

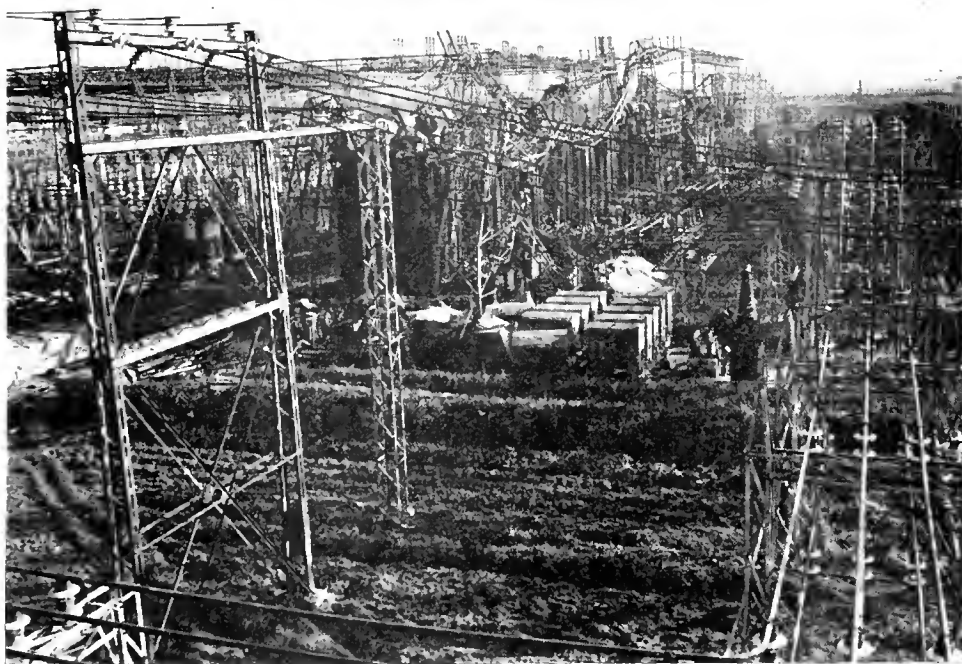
Photo 1—General view of main damaged section, looking south from control room

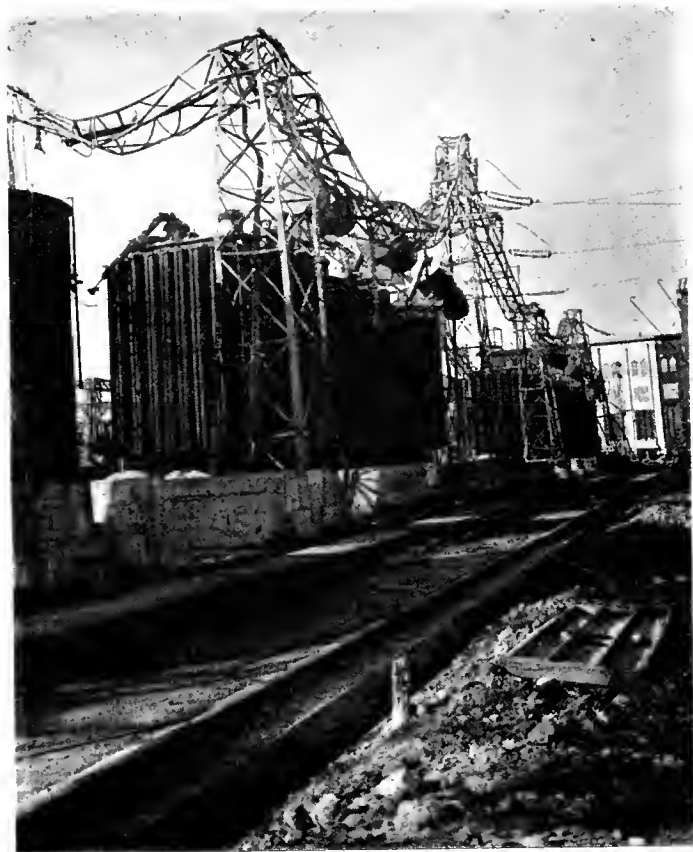
Photo 2—Closer view of damage to transformers and structure, looking north—synchronous condenser building in background
